DELIVERY REPORT

EECO Repair # 9999999
Sample Customer
Tuesday, November 05, 2013

Regarding: **TOSHIBA, HP-34.9, RPM-239, Volts-355, Amps-77, 60Hz**

Model: BPC026K5S052 Serial # 990702522 Enclosure: TENV Frame: 315LL, 3 Phase AC Motor

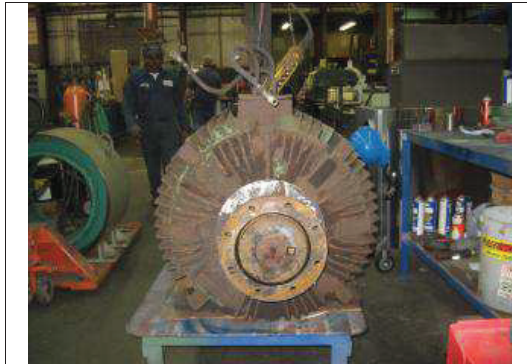
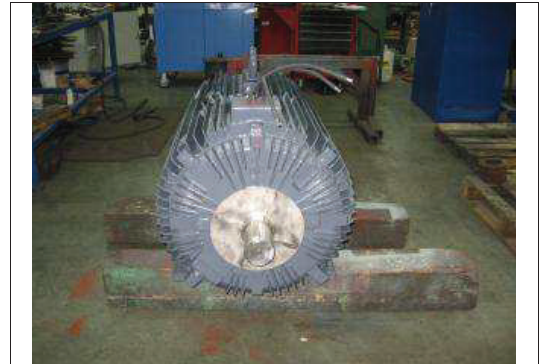
**DE
View**

DE Shaft Ext, DE Housing, DE Keyway, ODE Housing, Straighten shaft

- 1) TEST, DISASSEMBLE, CLEAN AND INSPECT UNIT.
- 2) Clean and strip stator, complete class-H rewind to stator.
- 3) DIP AND BAKE (2) TIMES
- 4) TEST SHAFT FOR RUN-OUT, INSPECT ALL BEARING FITS.
- 5) CLEAN, INSPECT AND PAINT ALL PARTS.
- 6) REPAIR DE SHAFT EXTENSION AND KEYWAY
- 7) BORE AND SLEEVE DE AND ODE HOUSINGS
- 8) STRAIGHTEN SHAFT
- 9) FABRICATE NEW SS SHAFT SLINGER
- 10) DYNAMICALLY BALANCE ROTOR.
- 11) BORE ENDBELL FOR INPRO SEAL
- 12) FURNISH AND INSTALL:
- 13) 2-NEW BALL BEARINGS
- 14) 2-NEW HOUSING SLEEVES
- 15) 1- NEW INPRO SEAL
- 16) ASSEMBLE, TEST, PAINT.

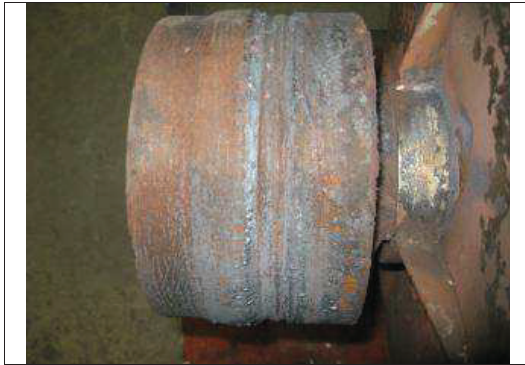
Analysis Picture 1

Sleeve Bearing, Seizures, Mechanical

Most Likely	Probable Cause1	Probable Cause2	Prevention Tips
<input checked="" type="checkbox"/>	Excessive axial loading	Defective coupling	Repair/replace coupling.
<input checked="" type="checkbox"/>	Excessive axial loading	Motor not mounted level	Level motor and realign with machine.
<input checked="" type="checkbox"/>	Excessive axial loading	Thrust being transferred from driven machine	Use a coupling that will not transfer the thrust.
